DEPARTMENT OF TRANSPORTATION**DIVISION OF ENGINEERING SERVICES**

Contract #: 04-0120F4Cty: SF/ALA Rte: 80 PM: 13.2/13.9File #: 69.28**WELDING INSPECTION REPORT****Resident Engineer:**Pursell, Gary**Address:** 333 Burma Road**City:** Oakland, CA 94607**Report No:** WIR-001561**Date Inspected:** 16-Feb-2008**Project Name:** SAS Superstructure**OSM Arrival Time:** 700**Prime Contractor:** American Bridge/Fluor Enterprises, a JV**OSM Departure Time:** 1500**Contractor:** Zhenhua Port Machinery Company, Ltd (ZPMC), Changxing Island **Location:** Shanghai, China**CWI Name:** Xu Le Feng, Ye Yong Jun**CWI Present:** Yes No**Inspected CWI report:** Yes No N/A**Rod Oven in Use:** Yes No N/A**Electrode to specification:** Yes No N/A**Weld Procedures Followed:** Yes No N/A**Qualified Welders:** Yes No N/A**Verified Joint Fit-up:** Yes No N/A**Approved Drawings:** Yes No N/A**Approved WPS:** Yes No N/A**Delayed / Cancelled:** Yes No N/A**Bridge No:** 34-0006**Component:** Tower Mock-ups and OBG**Summary of Items Observed:**

Tower Fabrication Facility

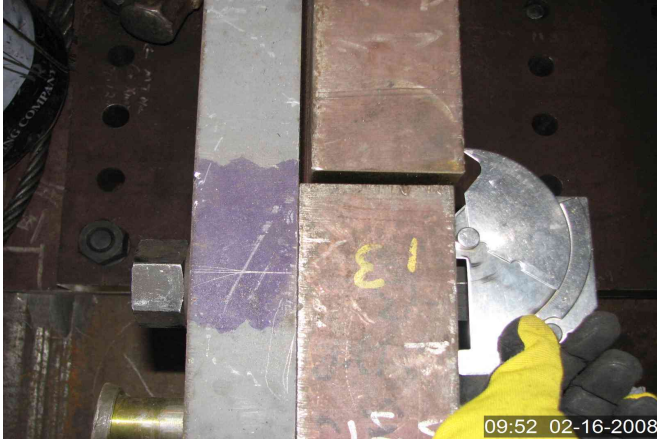
The Quality Assurance Inspector observed ZPMC utilizing five hydraulic jacks to aid in the fit-up of several internal bolted connection plates. An approximately 6 millimeter gap was observed between an internal bolted connection plate and a internal longitudinal stiffener prior to utilizing a 10 ton jack as illustrated in the digital photograph below.
